PHYTOTOXICOLOGY ASSESSMENT
SURVEY INVESTIGATION
IN THE VICINITY OF
CLINTAR GROUNDSKEEPING SERVICES
17 DUNDAS ST. E., MISSISSAUGA
JUNE 2, 1988

ARB-164-88-Phyto

Report prepared by:
R. Emerson

Phytotoxicology Section
Air Resources Branch

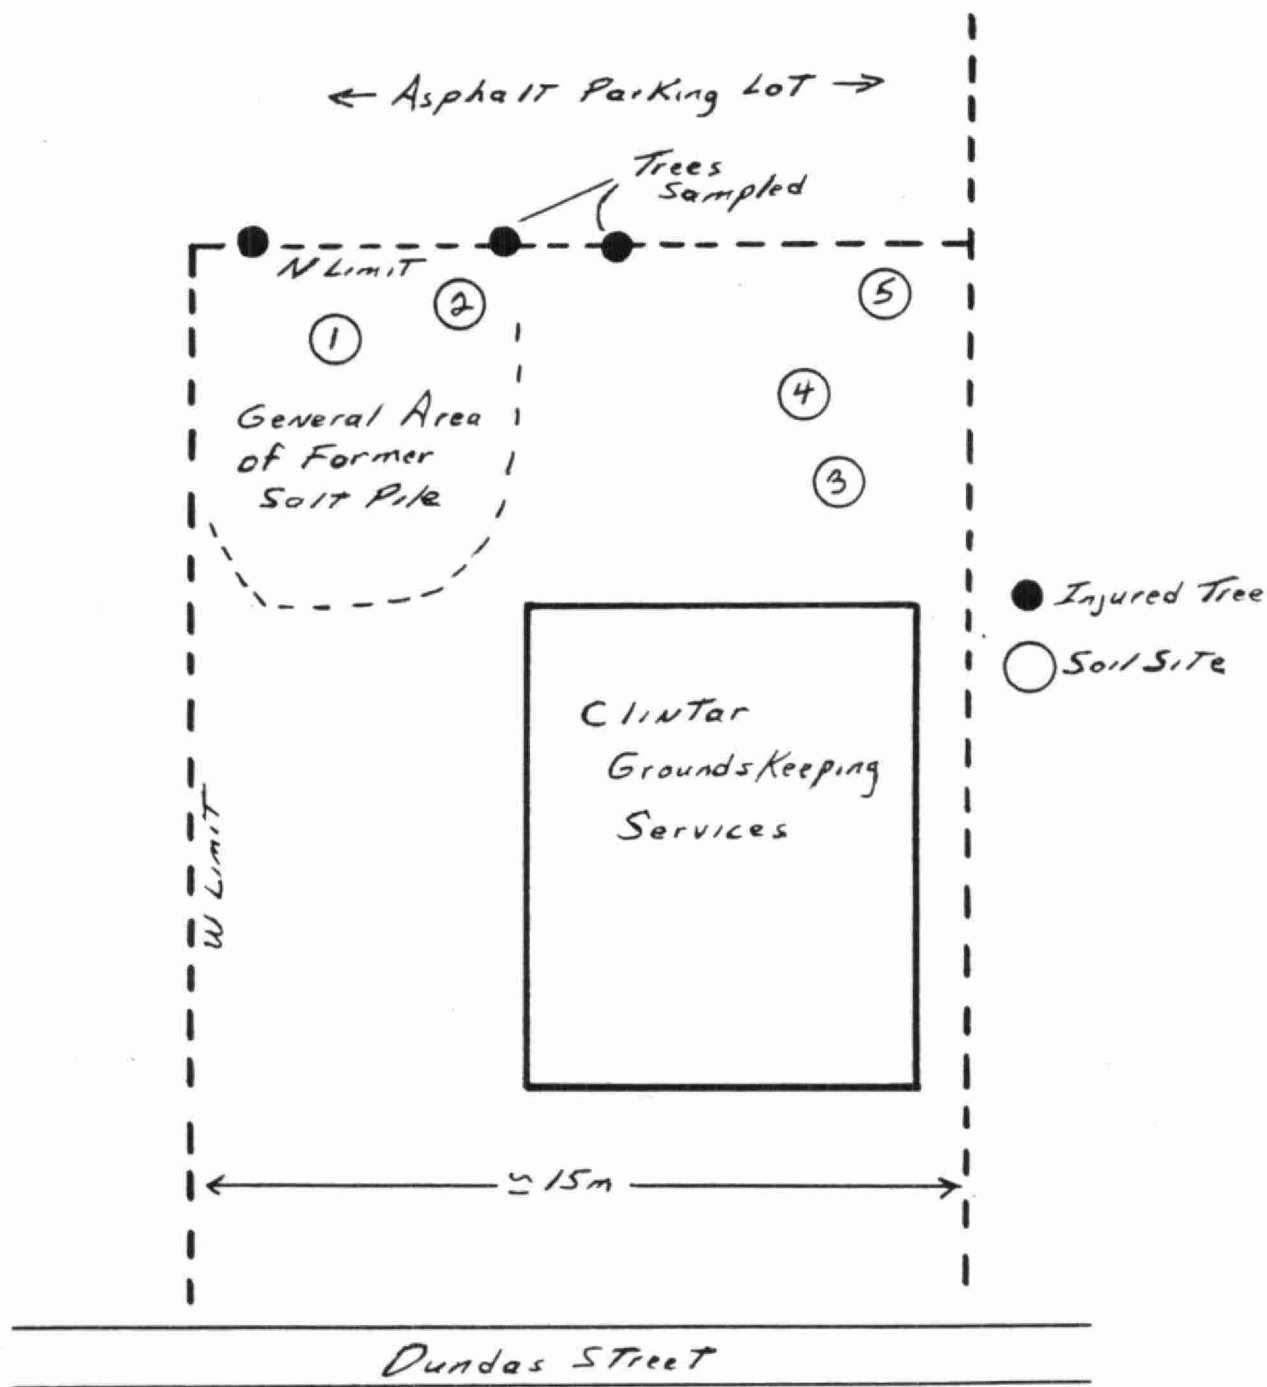
Sketch Map: Approximate Location of Injured Maple Trees and of Soil Collection Sites Relative to the Former Salt Pile on the Clintar Property.

The observations further revealed that three Norway maple trees to the neighbouring north of the former salt pile area were in various stages of decline. These mature trees were abutting the Clintar north property limit, and the base of each tree was embedded in the asphalt of the neighbouring parking lot to the north. The two maples closest to the former salt pile area (NW corner of Clintar property) were in the most advanced stage of decline, with foliage being absent throughout the crown of both trees. The barren branches throughout these trees exhibited

In the former salt pile area, scrapings of soil were collected at two sites (Sites 1 & 2 - see attached sketch) where the salt-like material was observed on the surface of the hard, clay soil. Surface soil also was sampled at Sites 3, 4 and 5 which were close to the E limit/NE corner. These sites were situated slightly upgrade of the former salt pile area and, to the writer's knowledge, no salt had been stored at these sites. As at Sites 1 and 2, the surface soil at Sites 3 and 4 had been previously removed to about a 15 cm depth. Site 5 had not been disturbed. In addition to the soil samples, twigs were collected from one of the leafless maples, as well as from the foliated tree to the immediate east. Control samples were collected from a healthy Norway maple tree which was situated at the east limit of the neighbouring north parking lot.

The surface soil scrapings collected in the former salt pile area (Sites 1 and 2) had excessive concentrations of total sodium (15,000 - 17,000 ppm) and water extractable chloride (30,000 - 33,000 ppm) relative to the corresponding levels found at Sites 3,4 and 5 near the east limit (see attached Table 1). The electrical conductivity of the surface soil sampled at Sites 1 and 2 also was found to be high (1,057 - 6,160 micromhos/cm), a further indication that the surface soil collected in the former salt storage area (Clintar NW corner) was contaminated with salt.
